INITIAL SITE INSPECTION OF MOTORCYCLE COLLISIONS WITH ROADSIDE OBJECTS IN NEW JERSEY

Paper Number 09-0450

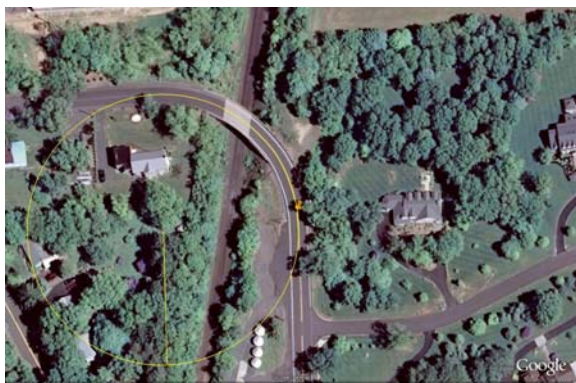
Figure 1. Example radius of curvature measurement from Google Earth Pro. This collision occurred in Mercer County on Route 640. The radius of curvature is 200 feet.

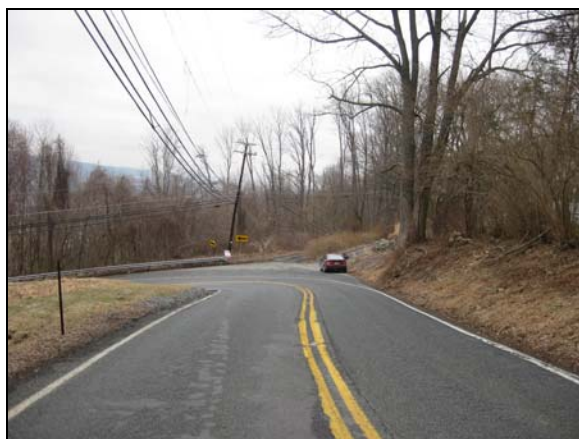
On Route 579 in Bethlehem Township in Hunterdon County, a crash location was investigated where there were 4 motorcycle-guardrail collisions in 2007. The posted speed limit on the road is 35 mph, with a reduction to 10 mph around the curve. The road took a sharp turn left, and disappeared from vision due to the downgrade of the road (Figure 3). There were two driveways ending at the curve.

Figure 3. Route 579, Bethlehem Township, Hunterdon County. Four motorcycle-guardrail collisions took place at this site in 2007.

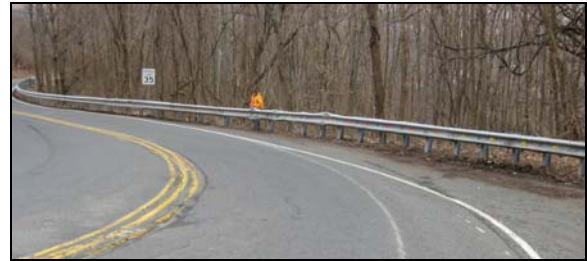
There were at least 5 areas of damage along the W-beam guardrail, suggesting other vehicle crashes had occurred on the same curve (Figure 4). Some of the steel strong posts were also bent and damaged.

Figure 4. Damage to guardrail. There is notable damage to the rail and the posts in multiple areas.

The distance of the guardrail from the edge of the lane gradually narrows as the road curves left. The guardrail-road offset distance was measured in three places to be 7.4, 5.0, and 4.0 feet from the edge of the lane. Along the curve, the guardrail was located only 0.75 feet from the edge of the pavement. The guardrail is in place to protect vehicles from the wooded slope behind it. The road slopes 11° in the direction of the road. The road angled 23° toward the center of the curve.

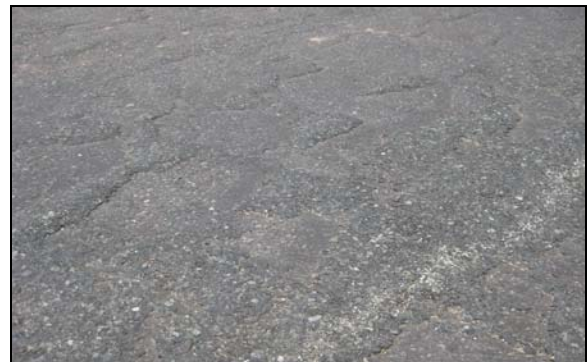
During the site visit, a street cleaner was seen at the site, implying that the site is well kept. There was little debris noticed on the side of the road as well. There were no potholes, patches, or large cracks in the asphalt surface of the road. However, the road was rough and uneven (Figure 5), which may be more hazardous for motorcycles than other vehicles.

Figure 5. Road Surface. The surface of the road was noted to be rough and uneven.

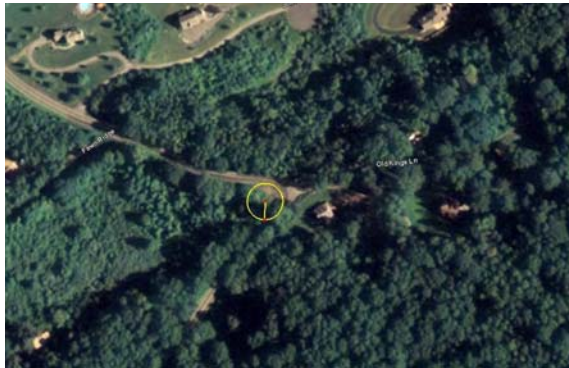
The geometry of the site was analyzed using Google Earth Pro. The radius of curvature of the site was measured to be 49 feet (Figure 6). This is a very narrow curve as none of the other sites investigated using the satellite imagery were found to have a radius under 100 feet.

Figure 6. Radius measurement of example site.
The radius of the curve was measure to be 49 feet.
